Do the CONTEC CMS8000 Patient Monitors Contain a Chinese Backdoor? The Reality is More Complicated...

claroty.com/team82/research/are-contec-cms8000-patient-monitors-infected-with-a-chinese-backdoor-the-reality-is-more-complicated

February 2, 2025

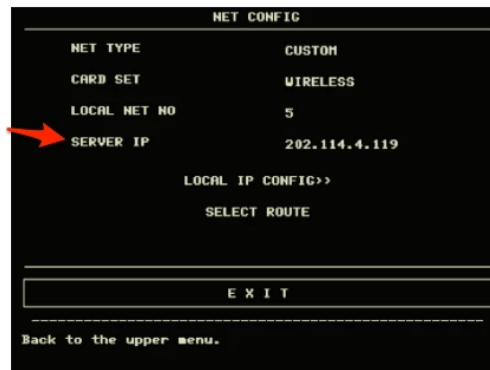
Figure 3-23 NET CONFIG

- **NET TYPE:**CMS/CUSTOM

CMS: the Server IP is fixed, "202.114.4.119". "LOCAL IP CONFIG" is unavailable.

CUSTOM: when this item is selected, CMS and machine's IP can be changed as you need. The following is "LOCAL IP SETUP" menu.

The Contec manual recommends the CMS hardcoded IP address: 202.114.4.119.

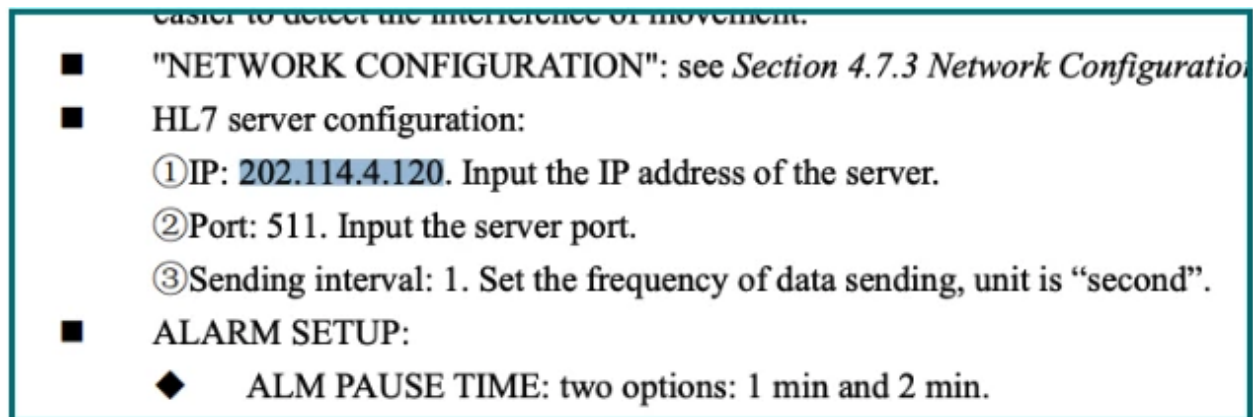
In addition to 202.114.4.119, another hardcoded IP address is used: 202.114.4.120 inside the firmware of the patient monitor. This IP address, also part of the routable subnet 202.114.4.0/24, is used by the patient monitor as a central HL7 server over TCP/511. The HL7 server allows the patient monitor to communicate and share the patient data it collects (heart rate, blood pressure, oxygen saturation, etc.) with other systems across the hospital. Once again we see that the vendor used a routable public IP address for this critical function handling sensitive patient information, which could lead to potential patient information leakage.

Part of the CMS8000 configuration, showcasing the default hardcoded HL7 server.

- If not using the HL7 capabilities of the patient monitor, it is recommended blocking all network traffic outbound to 202.114.4.120 to prevent potential PII/PHI leakage.
- These patient monitors are still running vulnerable code that will always be attempting to connect to an externally routable IP address, so it is recommended to replace them with a more secure device unless the vendor modifies firmware to prevent this action in the future.

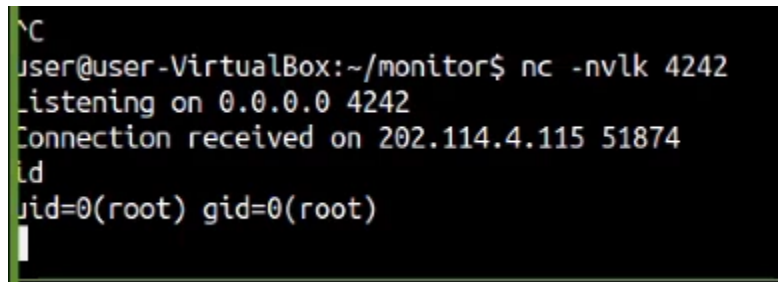
Our installed backdoor, giving us a reverse shell on the patient monitor in the root user's permissions.

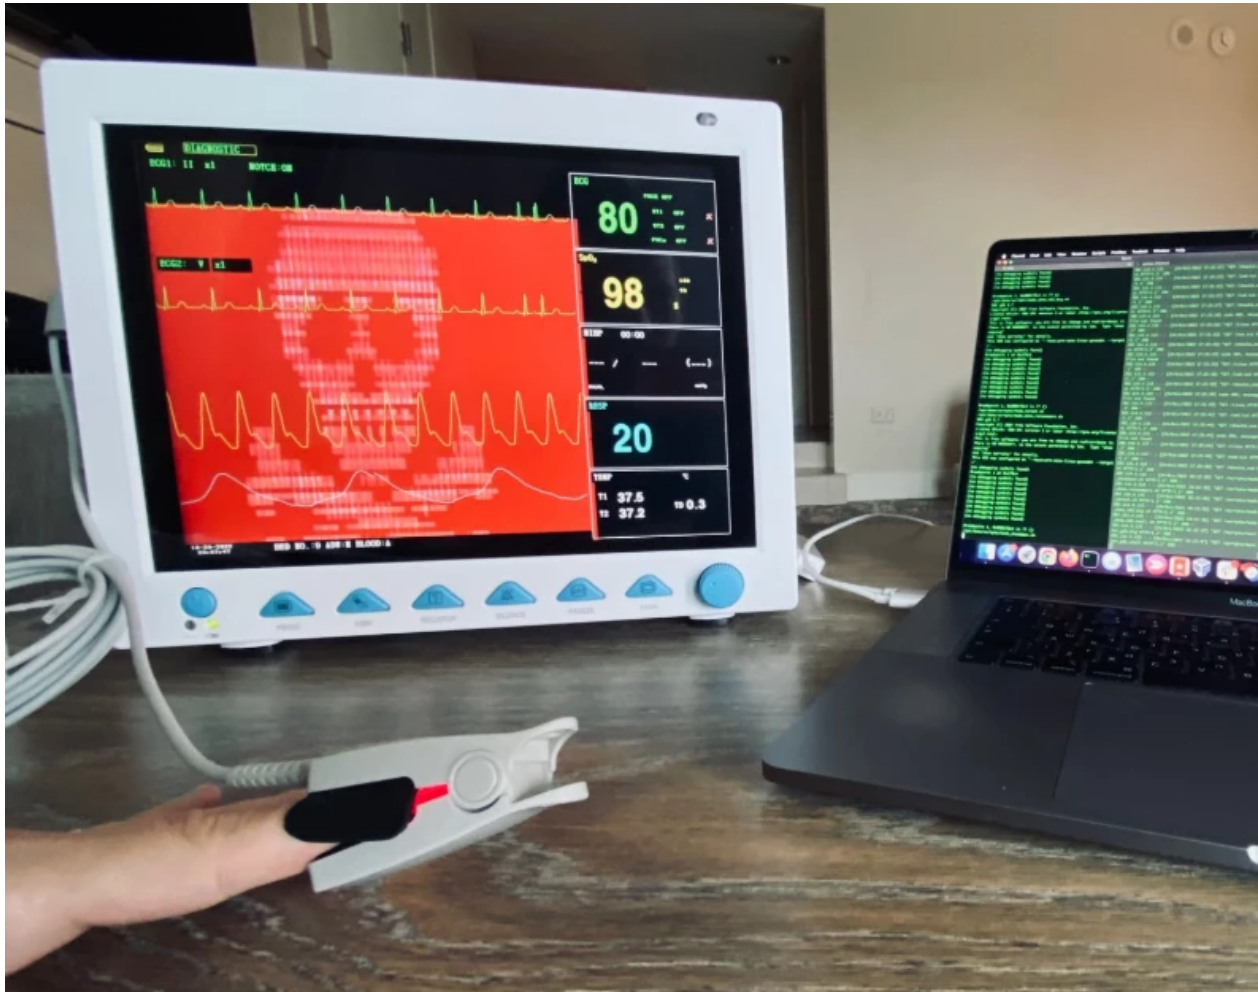
At Nexus Conference 2022, Team82 exploited this insecure design flaw and executed malicious code on a patient monitor.

- It is heavily recommended that organizations with this patient monitor block all access to the subnet **202.114.4.0/24** from their internal network, blocking devices from attempting to upgrade their firmware from a WAN server or send PII in the future.
- We have seen some OEM examples of the CONTEC CMS8000 where the default network configuration for the CMS can be modified. If this is possible, do not leverage the default **202.114.4.119** IP address for your CMS.
- If you do need to leverage a CMS for monitoring and providing updates to the CONTEC CMS8000 patient monitors or its white label variants, and must use the **202.114.4.119** hard-coded IP address, we recommend applying static routes and/or network segmentation to ensure that this traffic is routed only to your CMS and not externally.
