I am HDRoot! Part 1

Some time ago while tracking Winnti group activity we came across an intriguing sample.

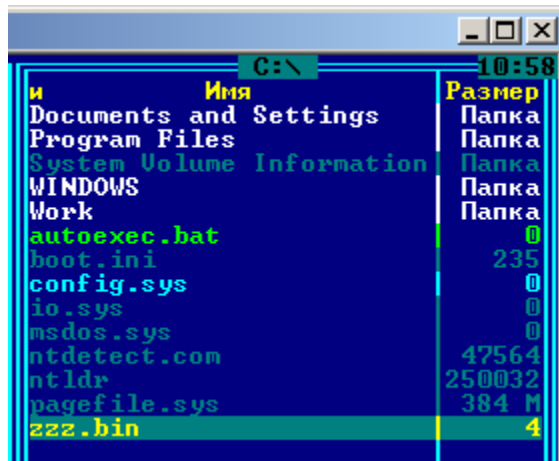
Created test file *zzz.bin*

The file *C:\zzz.bin* is seen immediately after Windows has loaded, which proves that the program *write_to_c.exe* has been successfully executed.

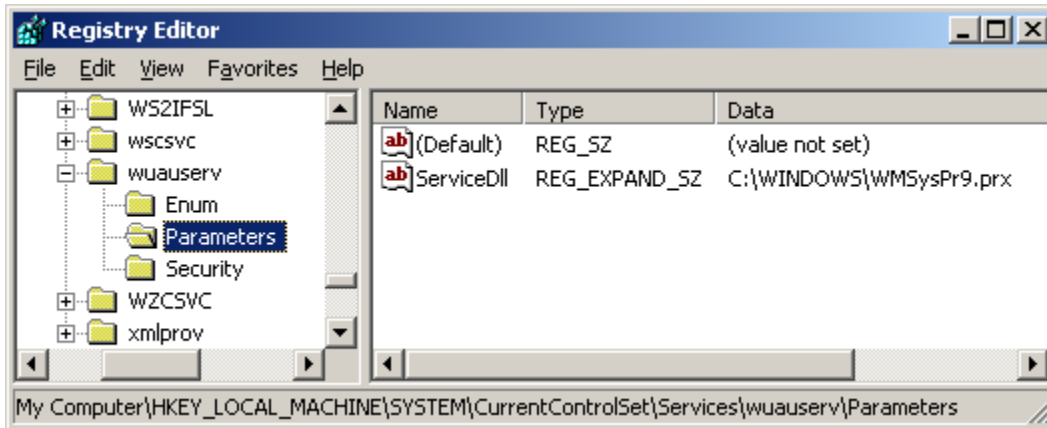
DLL from finding the proper registry path to *ServiceDll* to restore the original value. That's why, for example, "C:\WINDOWS\WMSysPr9.prx" can still be viewed instead of "C:\WINDOWS\system32\wuauiserv.dll" after logging on to Windows:

Path remains to injected malicious DLL in registry
